Hull Thickness Report of Marine Survey
Of a 50 Custom Sloop Steel Sailing Vessel

EVANNA

John N. Allinson, II
INDEPENDENT MARINE CONSULTANT
SAMS® ACCREDITED MARINE SURVEYOR
Certified Infrared Thermographer

PREPARED FOR: Carol & Peter Evans
DATE: 27 February 2007

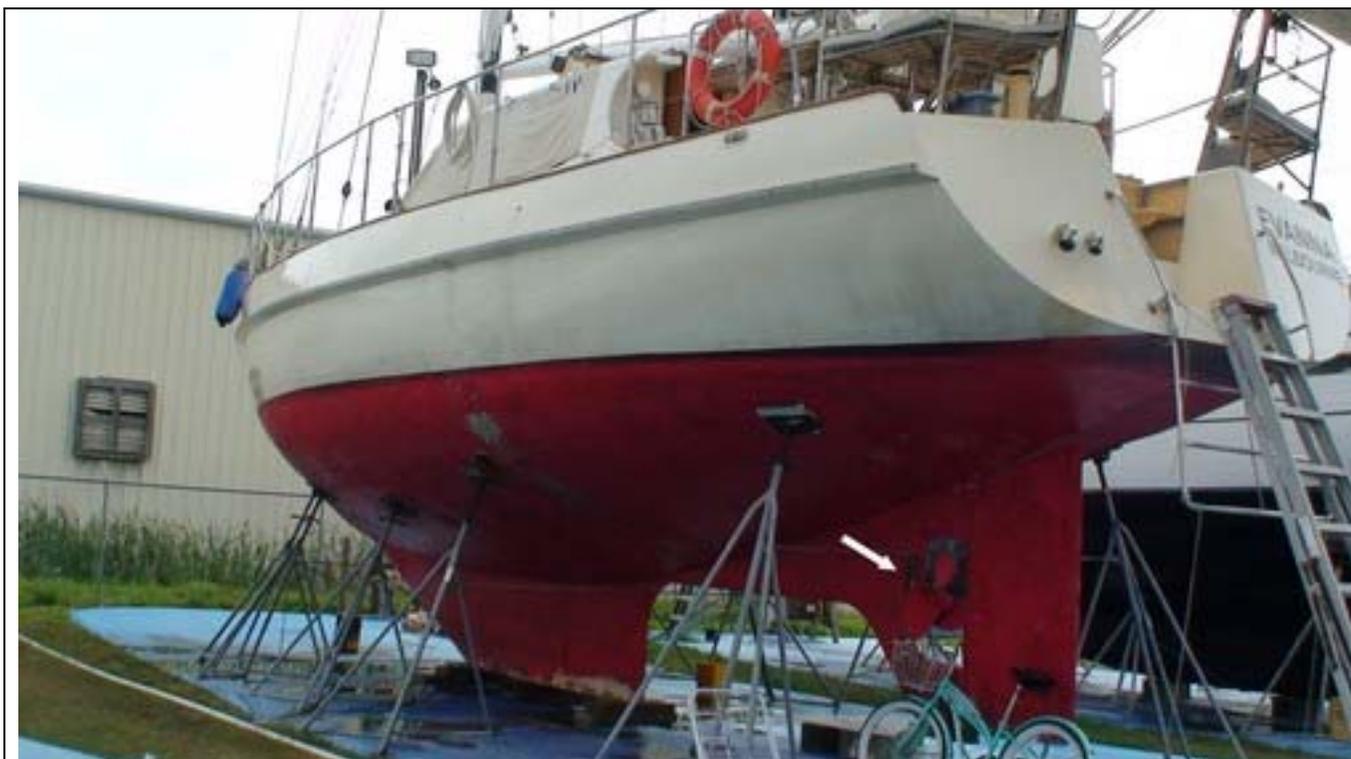
Port side stern view. White arrow in photograph near the propeller shows the area that was welded in the hull to stop a water leak.

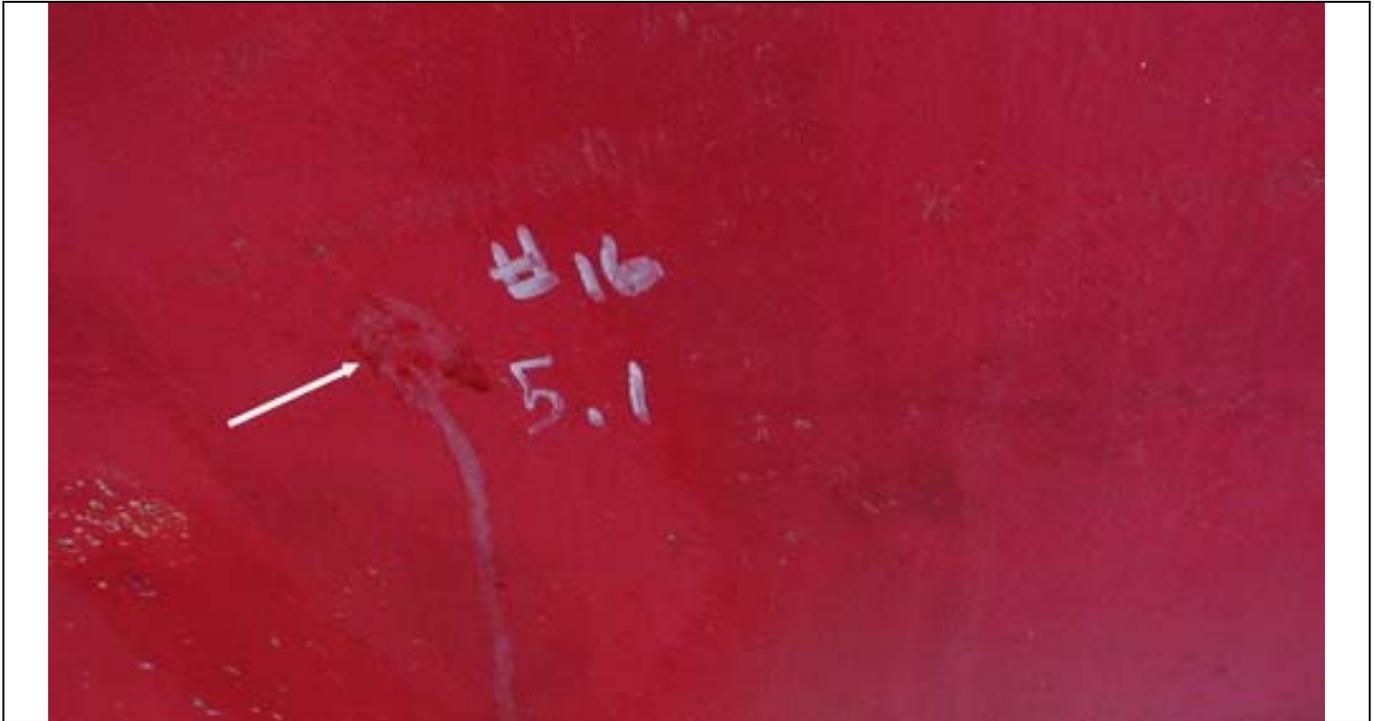
An inspection of this vessel's hull by visual, infrared and audio gauging of specific areas of interest to Mr. Evans revealed that there was no metal wastage in excess of twenty five (25%) of the original steel plate thickness.

White arrow points to area audio gauged. This is station #16 thickness 5.1 mm

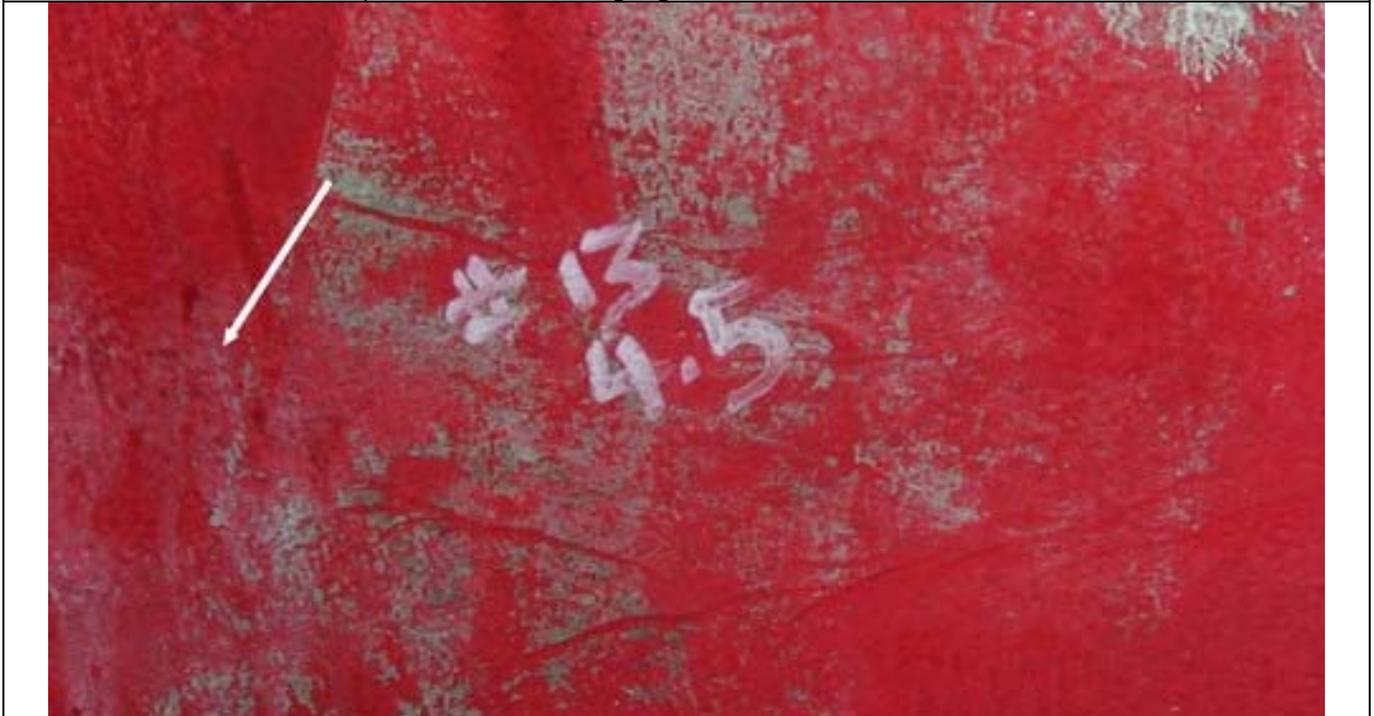
White arrow points to area audio gauged. This is station #13 thickness 4.5 mm

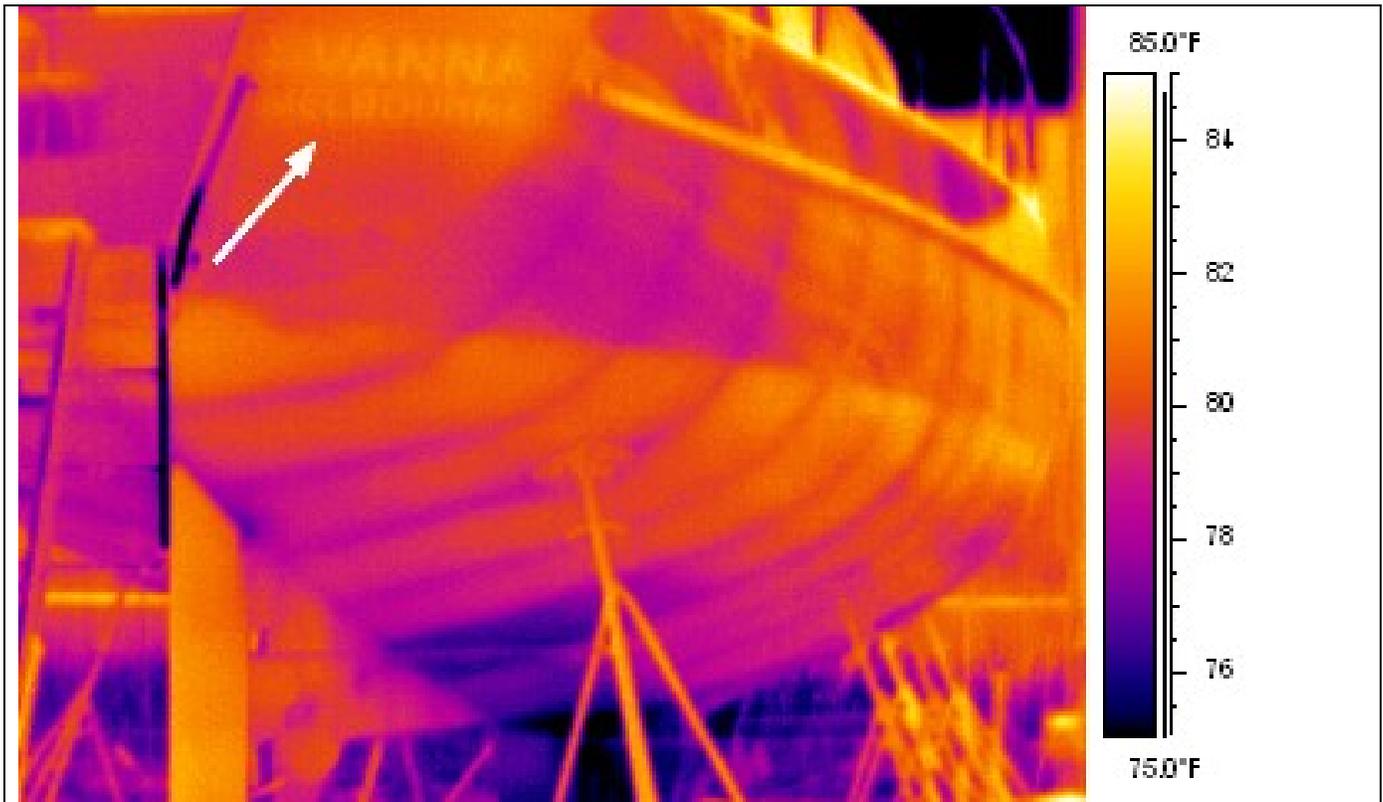
White arrow points to signage on starboard side transom of "EVANNA". Temperature patterns on hull surface reveals location of internal structures.

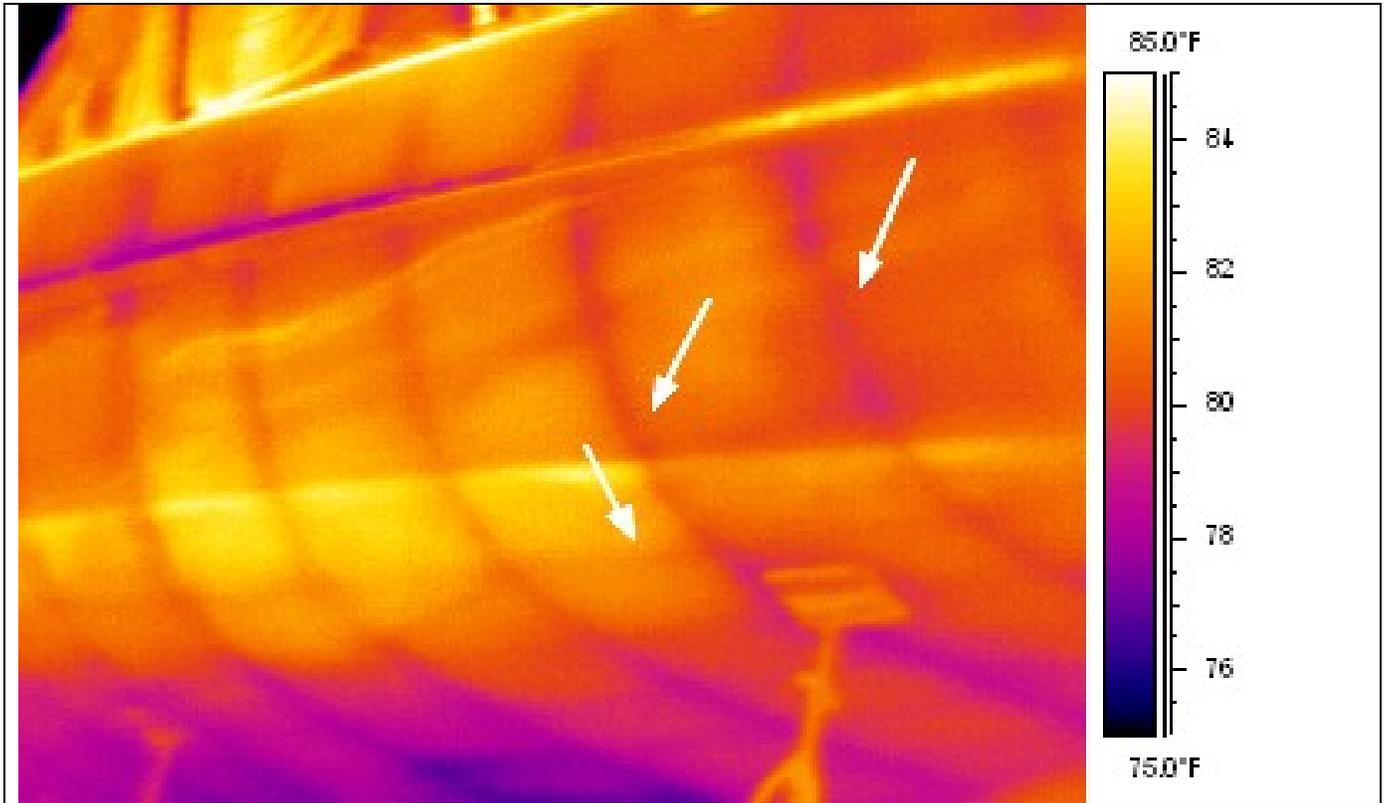
White arrow points transverse and longitudinal frames. Locations are revealed by temperature patterns on hull surface.

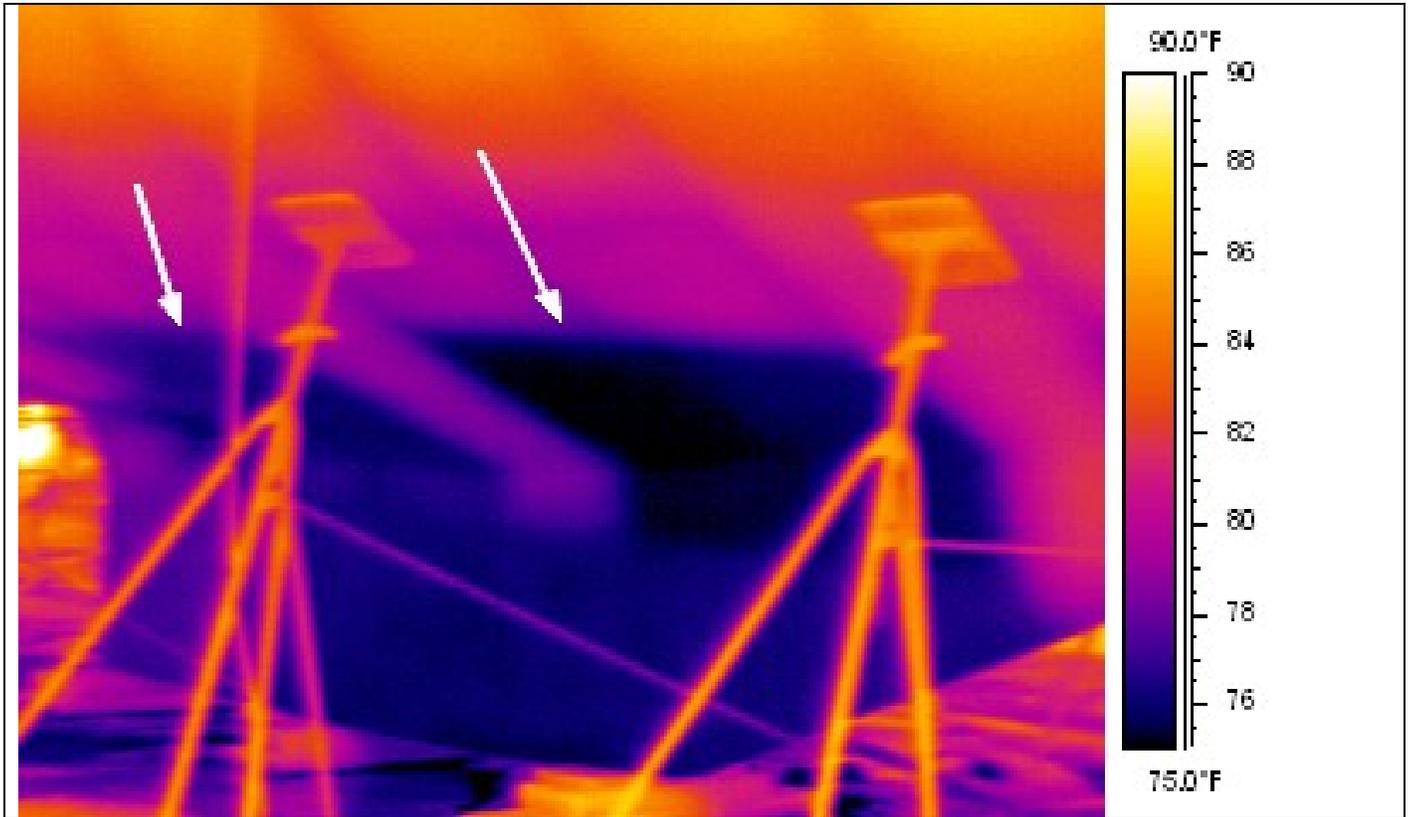
White arrows point to storage tanks (water, waste, and fuel) on the interior of the vessel are revealed by temperature patterns on hull surface.
